Manhole Inspection Summary

Manhole # S31II_001MH

Insp Date: **4/11/07 1:30 PM**

Location Address: **1341 MOUNT ROYAL AVE**

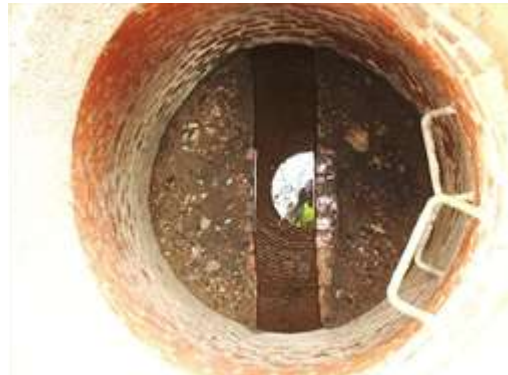
Top View

Condition: ☒ Sound ☐ Cracked ☐ Root Intrusion ☐ Deteriorated ☐ Leaks ☐ Debris

Condition: ☐ Sound ☐ Cracked ☐ Root Intrusion ☐ Deteriorated ☐ Leaks ☒ **Debris**

Bench and Channel debris.

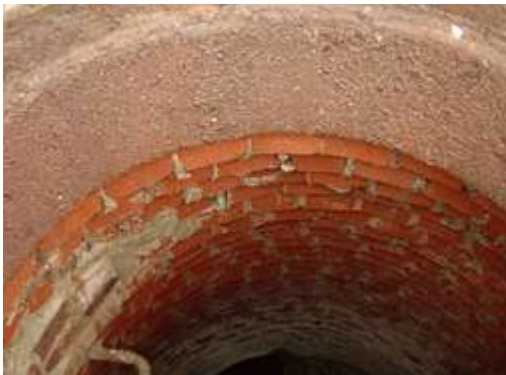
Defect

☒ **Leaks**

Infiltration: ☐ None ☒ **Joint** ☐ Cracks ☒ **Mortar** ☐ Roots ☐ Wall

Infiltration: ☐ None ☐ Joint ☐ Cracks ☒ **Mortar** ☐ Roots ☒ **Wall**

Frame leaks. Adjustment, Corbel and Barrel infiltration - other side.

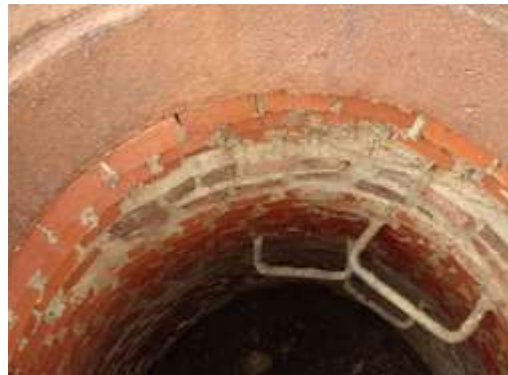
Defect

Frame leaks. Adjustment, Corbel and Barrel infiltration.

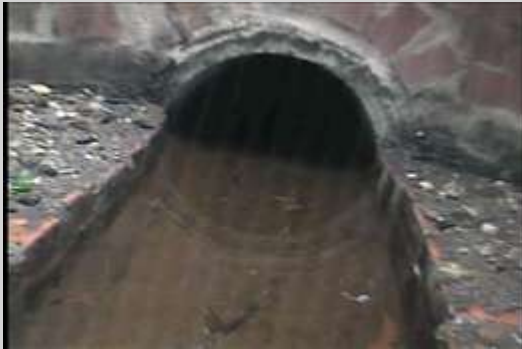
8 in. Circular Gravity Sewer Pipe Out @ 12 O'Clock

Deposits: ☐ None ☒ **Mud** ☐ Sludge ☒ **Debris** ☐ Grease

Silt Depth: **3** (in.) Deposits Extent: **Medium**

Infiltration: **None** Pipe Seal Cond: **Unknown**

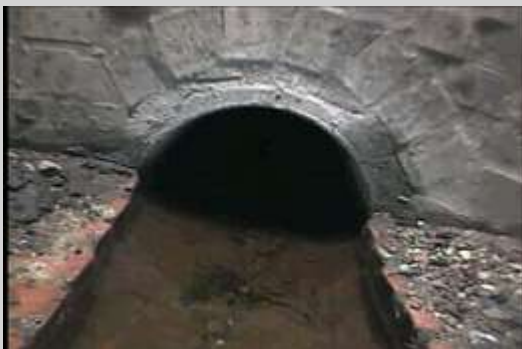
8 in. Circular Gravity Sewer Pipe In @ 6 O'Clock

Deposits: ☐ None ☒ **Mud** ☐ Sludge ☒ **Debris** ☐ Grease

Silt Depth: **3** (in.) Deposits Extent: **Medium**

Infiltration: **Evidence** Pipe Seal Cond: **Unknown**

Drop: **Inside** **Rod and Bar**
Angled: **Yes** Reading: **7.98** (ft.)
Inv Depth: **8.98** (ft.)

Drop Condition: **Open**
